CASE STUDY

VARB—PF Diffuser at Ontario Power Station, Canada

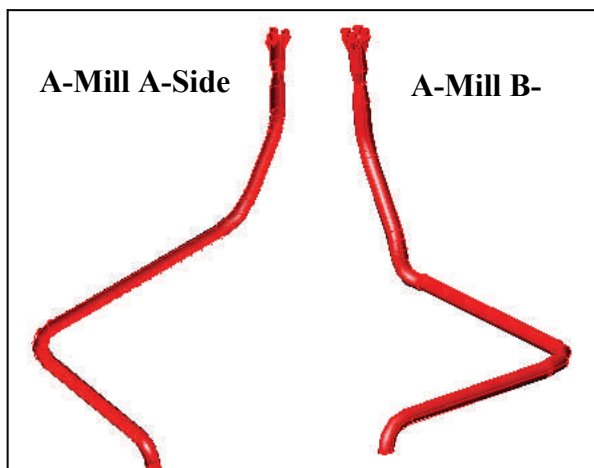
Figure 1: A-Mill A side and A-Mill B

The scenario consists of a mill with two outlets that then travel horizontally for the majority of their run before turning 90° into the vertical. The two runs are shown in figure 1. There is then less than 5 pipe diameters before the primary pipe is split into four by quadrifurcations. The nominal bore of the primary pipe is 711mm (approximately 27”) and the secondary pipes at 356mm (approximately 14”).

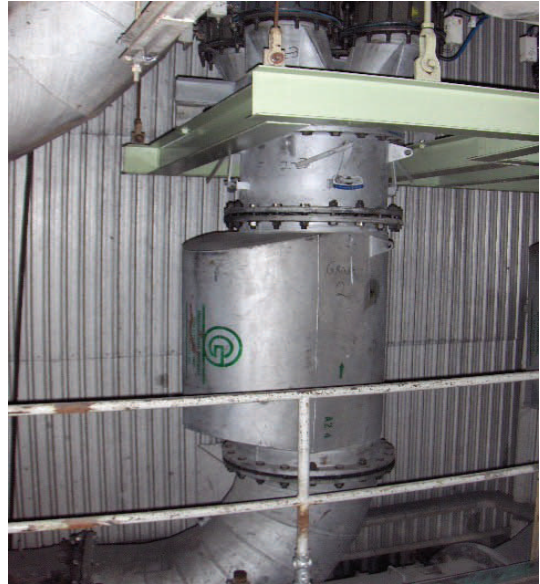
Figure 3: H-VARB in position at Nanticoke

GAIM Ltd. (part of The Greenbank Group) provided CFD analysis to identify which VARB solution would be appropriate. It was decided that an aggressive H-VARB solution would be needed. The scenario had a tight horizontal to vertical bend and a limited envelope for any installation, as a result a H-VARB was utilized along with a control gate device.

The C.F.D. investigation indicated the orientation of the H-VARB device and possible initial positions for the control gate plates.

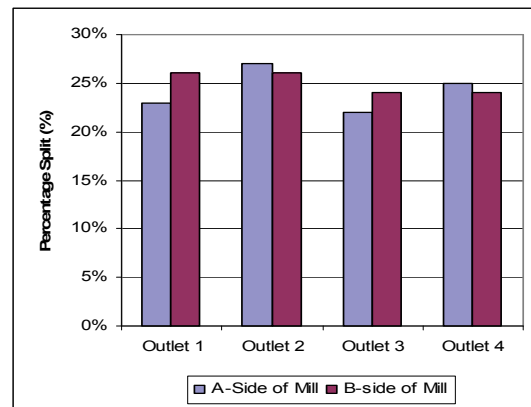
Figure 4: Graphs showing comparison between A-Side and B-Side

Both quadrifurcations were successfully balanced to within +/- 15% of the RMS across all eight burners fed to the mill.

A Side			
Outlet 1-1	Outlet 1-2	Outlet 1-3	Outlet 1-4
23%	27%	22%	25%
B Side			
Outlet 2-1	Outlet 2-2	Outlet 2-3	Outlet 2-4
27%	26%	22%	25%
